INSTALLATION RESTORATION PROGRAM

PRELIMINARY ASSESSMENT

BETHEL RADIO RELAY STATION, ALASKA

April 1989

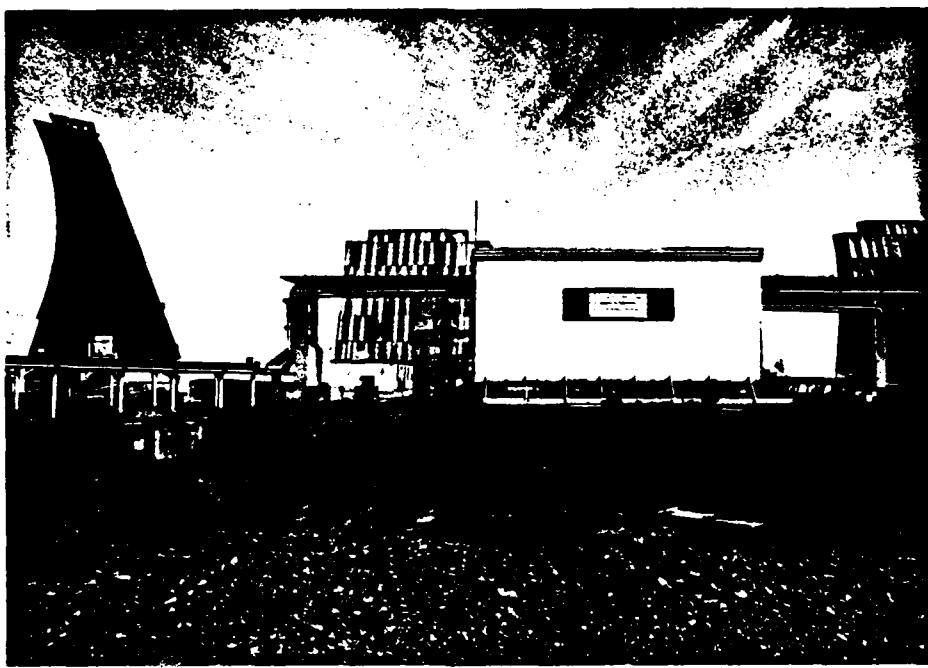
Photo 1. Bethel RRS-View Looking North, from left to right: Antenna No. 1, Facility Support Bldg., (front), Antenna No. 6 (back), Equipment Bldg, and Antenna No. 5.

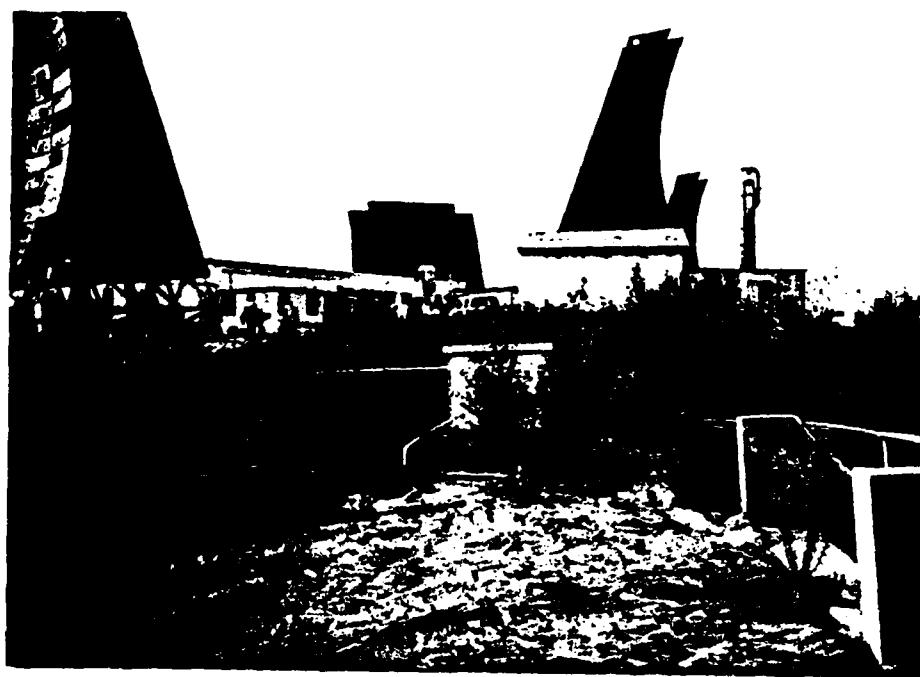
The Petroleum, Oils, and Lubricants (POL) facility consists of two empty concrete tank holders, a pump house, and piping to the Vehicle Maintenance facility. Stained soil and a petroleum odor were observed during the site visit. The stained areas were approximately 20 feet by 20 feet near the pumphouse and 10 feet by 20 feet in the concrete holders. Small stains were also found at the ends of the holders.

Two fuel tank stands and their associated piping are located on the right-hand side of the road to the RRS. The fuel tanks have been removed, but the pipes are still intact. Stained soil and a strong fuel odor were observed. However, results obtained with the photoionization detector (PID) were negative. The soil was stained to a depth of several inches and covered an area approximately 20 feet by 20 feet by the pumphouse and 10 feet by 20 feet in the concrete holders and 3 feet by 5 feet at the ends of the holders. Photographs 3, 4, and 5 (Appendix E) show these areas.

Photo 3. Site No. 1 - POL Facility - Tank Holders.

Photo 4. Site No. 1 - POL Facility - Pumphouse.

Photo 5. Site No. 1 - POL Facility - Holders and Piping.

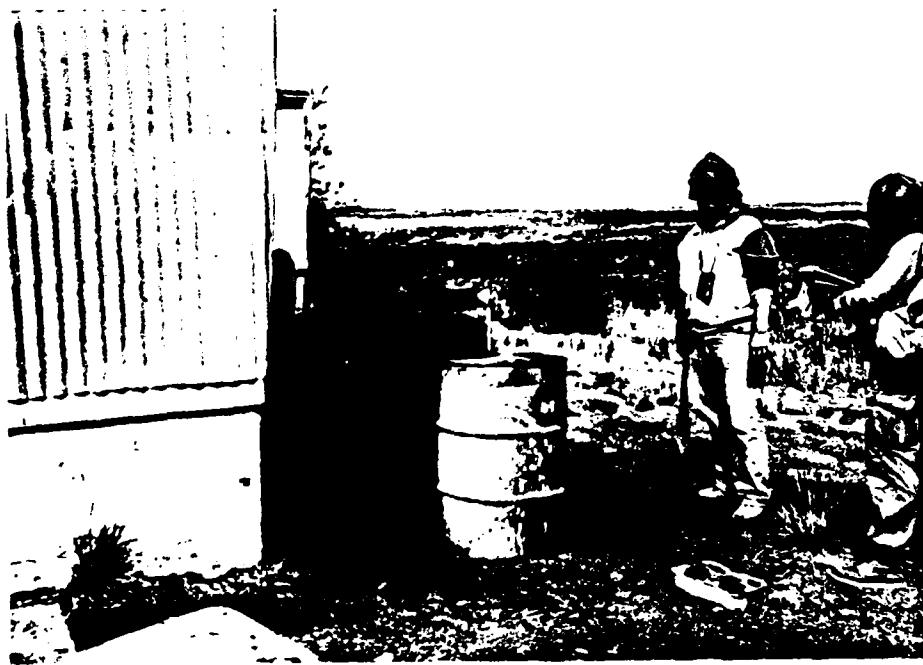
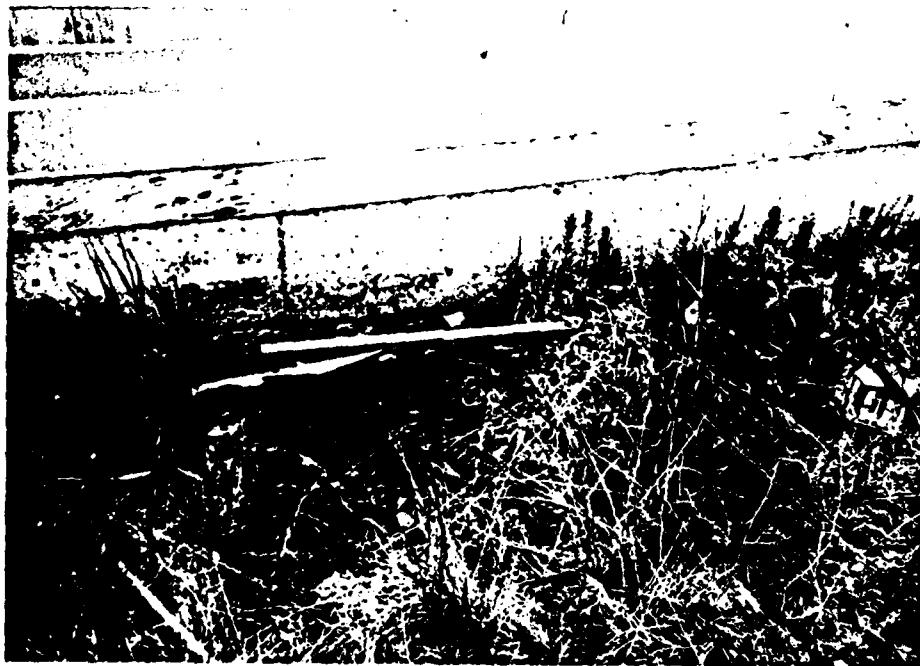
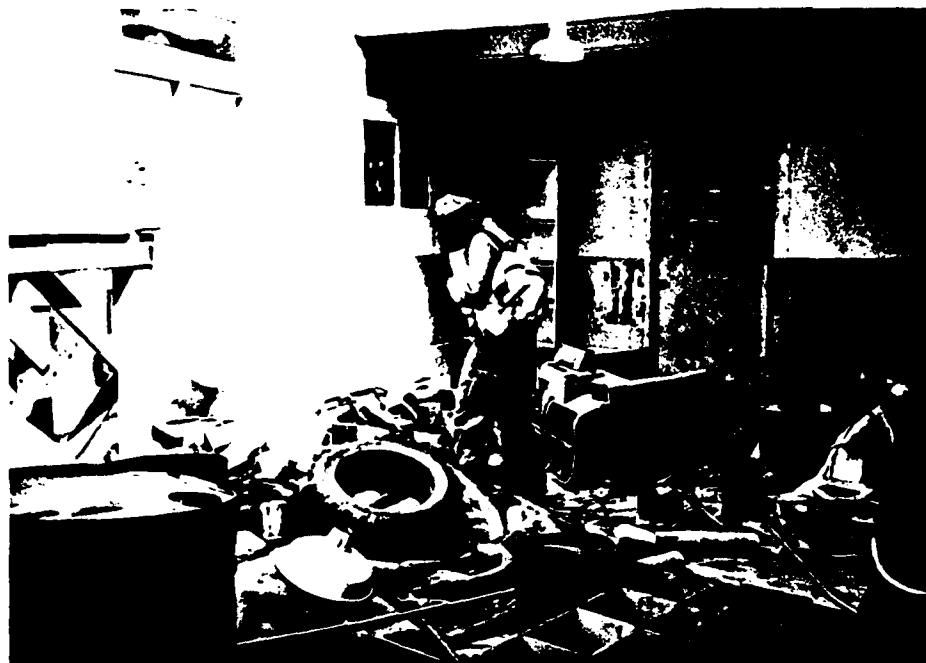
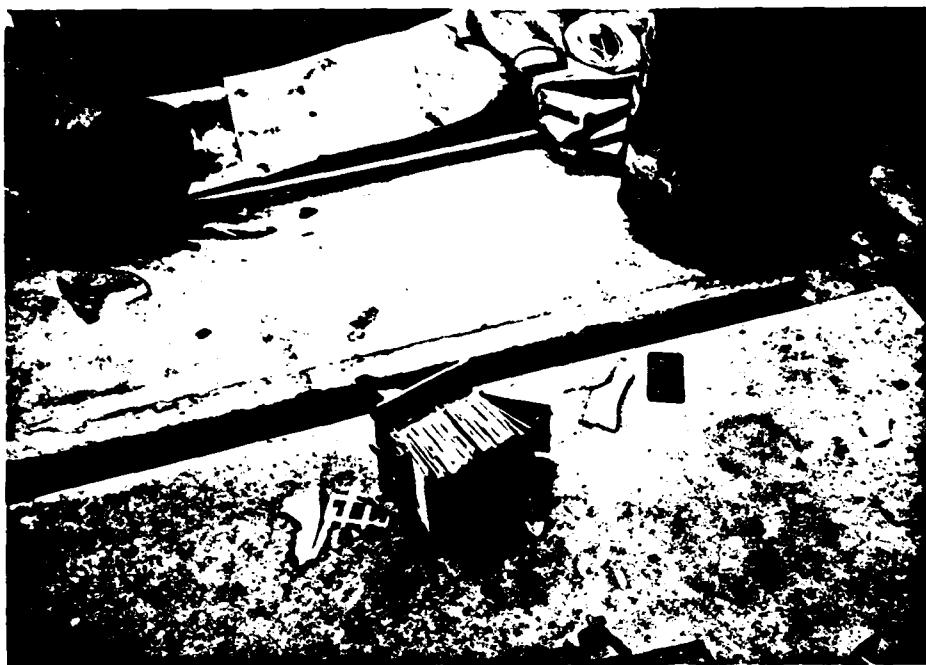
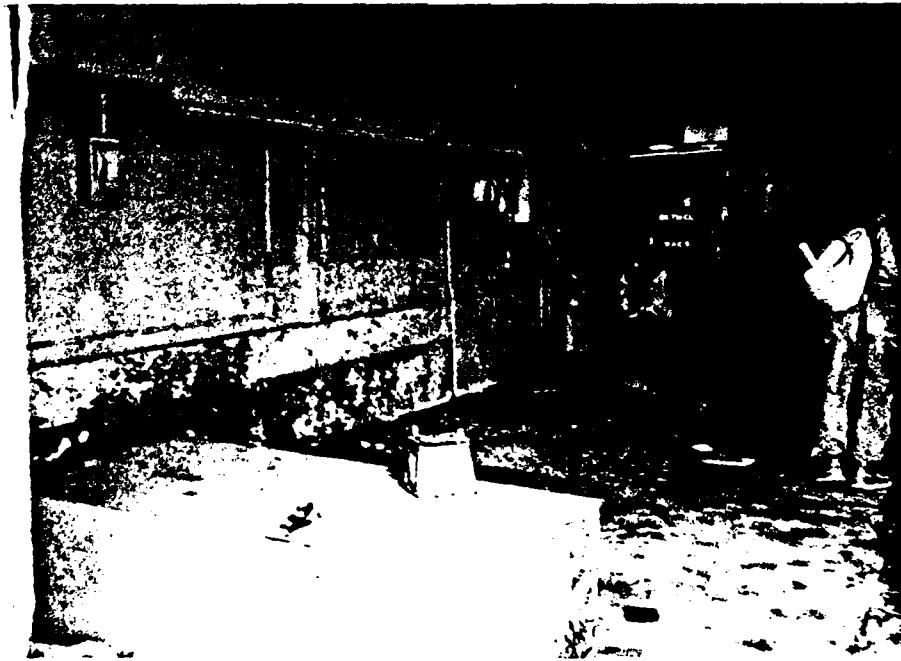
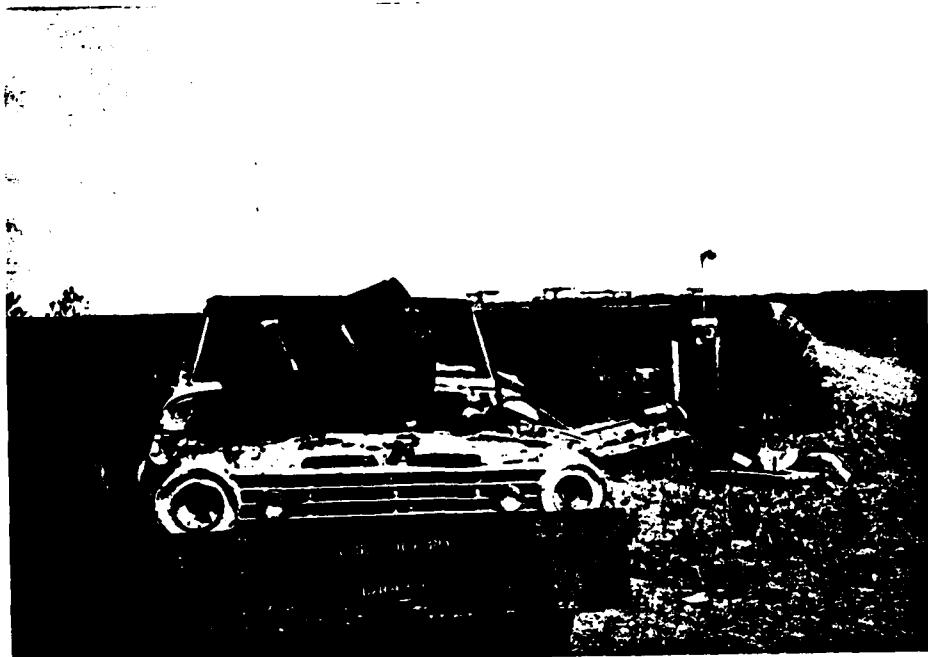
The Vehicle Maintenance facility consists of an abandoned building with several vehicles and a fuel pump. Within the building there were drums and cans of paints, thinners, alcohol, oils, and other vehicular fluids. Outside the building there was stained soil at various locations around the building's edge. Empty containers on the ground usually accompanied areas of stained soil. None of the stains was more than 3 feet in diameter. It is unknown whether the fuel pump was connected to an underground storage tank or was directly supplied by the POL facility.

The Vehicle Maintenance building was heavily ransacked, showing major damage. Unlabeled drums, stained soil, and general debris were located around the outside of the building. The stained areas were approximately 3 feet in diameter. Unlabeled cans and drums were also found at the stained areas. Photographs 6, 7, 8, and 9 (Appendix E) show these areas. Inside the building, drums of isopropyl alcohol, lube oil, refrigerant compressor, paint, white oil, oil sludge, transmission fluid, and rust inhibitor were found in various stages of deterioration. Also various vehicle parts, filters, and debris were found (see Photographs 10, 11, 12, 13 and 14; Appendix E). A fuel pump is located outside of the building on the east side (see Photograph 15; Appendix E). It is unknown if the pump was supplied directly from the tanks at the POL Facility or if it was connected to an underground storage tank.

Photo 6. Site No. 2 - Vehicle Maintenance Bldg. - Drum and Stained Soil.

Photo 7. Site No. 2 - Vehicle Maintenance Bldg. - Drum and Stained Soil.

Photo 8. Site No. 2 - Vehicle Maintenance Bldg. - Stained Soil.

Photo 9. Site No. 2 - Vehicle Maintenance - Drum.

Photo 10. Site No. 2 - Vehicle Maintenance - Front View.

Photo 11. Site No. 2 - Vehicle Maintenance Bldg. - Inside View (back room).

Photo 12. Site No. 2 - Vehicle Maintenance Bldg. - Sludge Drum.

Photo 13. Site No. 2 - Vehicle Maintenance Bldg. - Filter and Debris.

Photo 14. Site No. 2 - Vehicle Maintenance Bldg. - Inside View (front room).

Photo 15. Site No. 2 - Vehicle Maintenance Bldg. - Fuel Pump, Truck and Drum D-9 (label on opposite side).

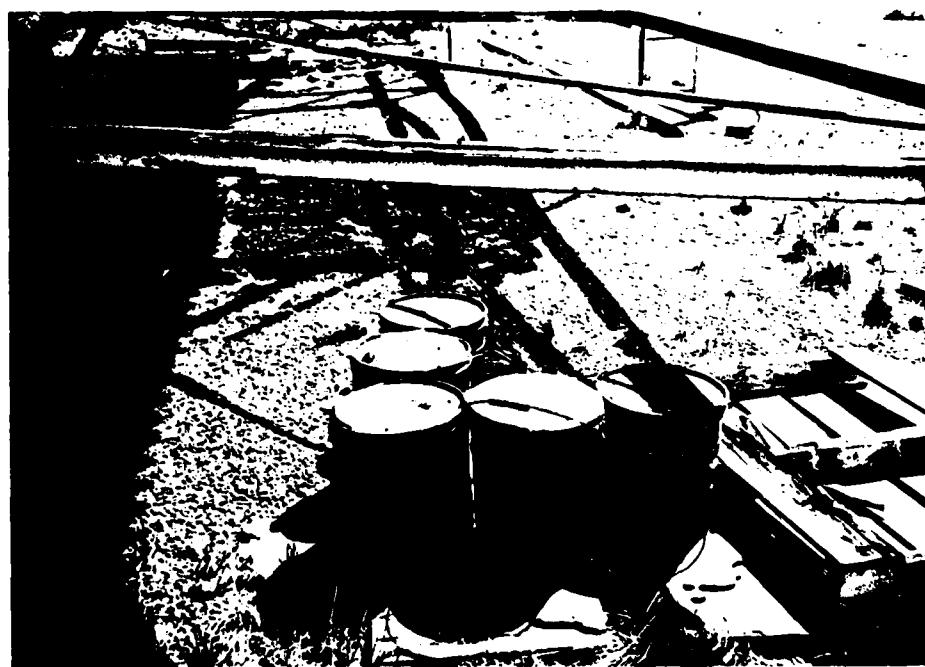
Several 5-gallon cans were found under Antenna No. 1. The cans were on gravel and were leaking a black, sticky, thick substance. The surface area of the stain was confined to an area no larger than 3 feet around the cans.

Four unmarked 5-gallon cans located under Antenna No. 1 were found leaking a dark sticky substance. The leaking material was confined to a small area no larger than 3 feet from around the cans. Photograph 16 (Appendix E) shows this site.

Photo 16. Site No. 3 - 5-Gallon Cans under Antenna No. 1.

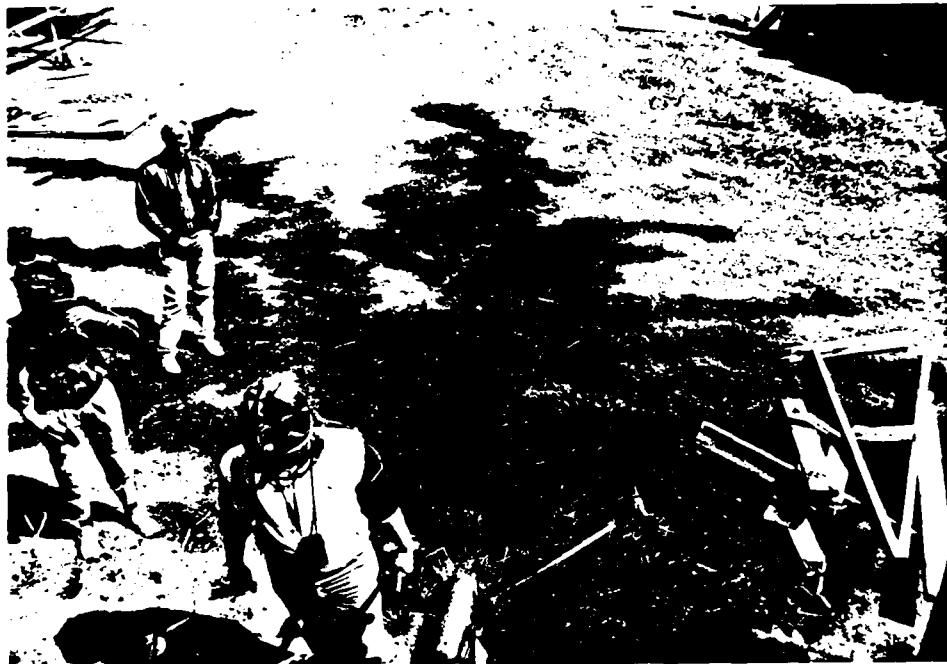
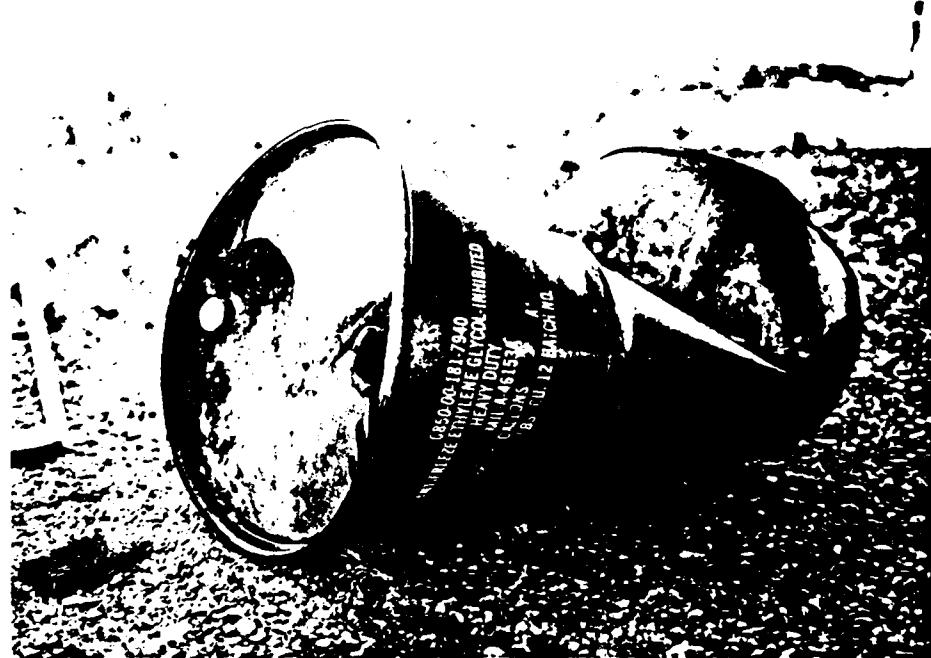
At the north end of the Equipment Building, several drums filled with either a yellow or brown, thick, sticky substance were found. Unlabeled 5-gallon cans and fire extinguisher canisters were also found. The ground around the containers was heavily stained over an area approximately 10 feet by 30 feet.

At the north end of the Equipment Building, six unlabeled drums containing either a black or yellow oily substance were found. Some of the drums were partially full; others were empty. Leakage was evident and extended over a distance of 30 feet by 10 feet. The condition of the drums ranged from slightly weathered to crushed. The drums were numbered in sequence from D-2 through D-6, and D-9; drum D-9 was found at Vehicle Maintenance (see Photograph 15; Appendix E). Empty fire extinguisher canisters, unlabeled 5-gallon cans, and empty drums of ethylene glycol under the building were

also found at this site. Photographs 20, 21, 22, 23, 24, and 25 (Appendix E) show this site.

Photo 20. Site No. 5 - Drums, Cans, and Canisters - Side View.

Photo 21. Site No. 5 - Drums, Cans, and Canisters - Top View.

Photo 22. Site No. 5 - Drums, Cans, and Canisters - Contaminant Migration.

Photo 23. Site No. 5 - Drums, Cans, and Canisters - Contaminant Migration (Top View).

Photo 24. Site No. 5 - Drums, Cans, and Canisters - Numbered Drum.

Photo 25. Site No. 5 - Drums, Cans, and Canisters - Empty Ethylene Glycol Drum.

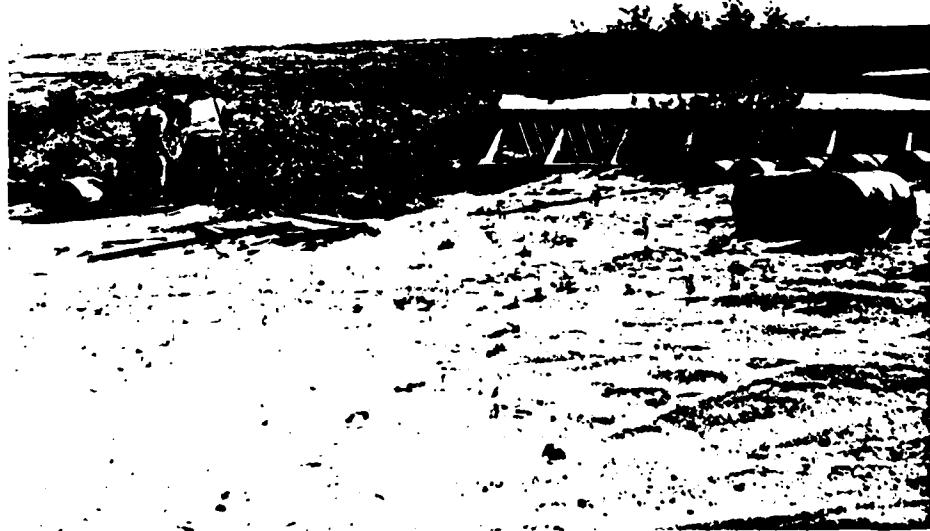
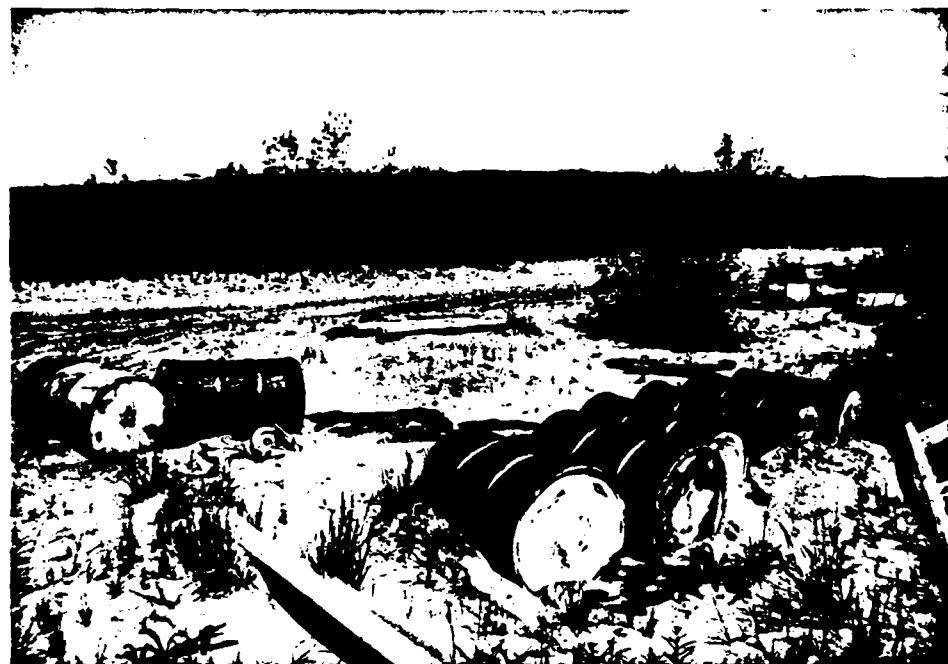
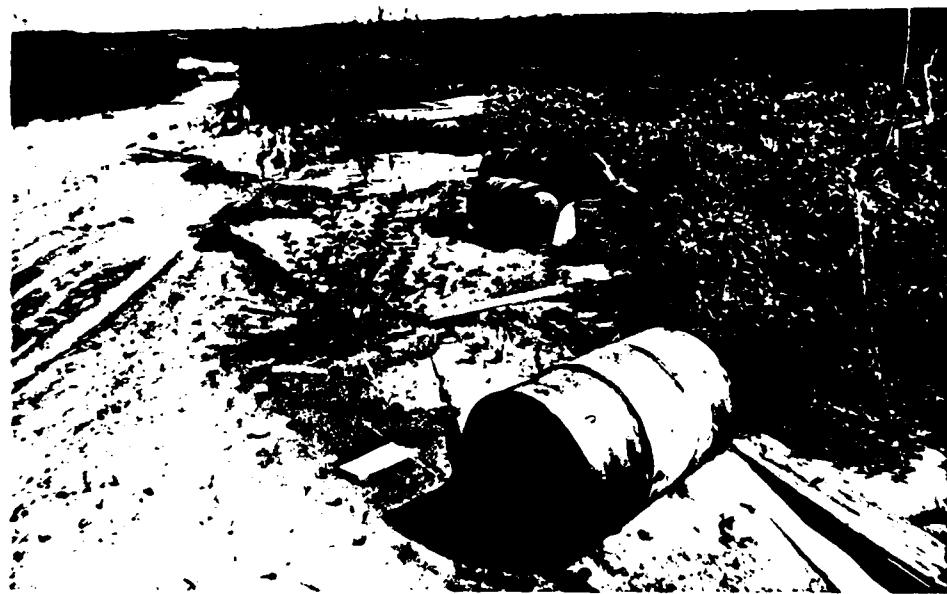
At the entrance of the east unpaved road, twelve 55-gallon drums were found in a row. The drums were laying horizontally and had been gun shot, thus releasing their contents. The drums leaked either a black, thick sticky substance or a thin light colored substance that absorbed into the ground. The stained areas ranged in size from a few square feet to approximately 30 feet by 10 feet, downslope from the drums.

Twelve unlabeled 55-gallon drums, lying horizontally, were found northeast of Antenna No. 5, at the entrance of the unpaved road leading east from the RRS (see Photograph 26; Appendix E). The drums had been gun shot, allowing the contents to drain onto the ground. The drums also showed signs of rust. The contents of eight of the drums appeared to be a black, thick, sticky substance (see Photograph 27; Appendix E). Results from a PID survey were negative. The material leaked no more than a few feet. The other four drums leaked a thin, clear substance leaving a stain approximately 30 feet by 10 feet (see Photograph 28; Appendix E).

Photo 26. Site No. 6 - Horizontal Drums - Front View.

Photo 27. Site No. 6 - Horizontal Drums - Thick Substance Migration.

Photo 28. Site No. 6 - Horizontal Drums - Thin Substance Migration.

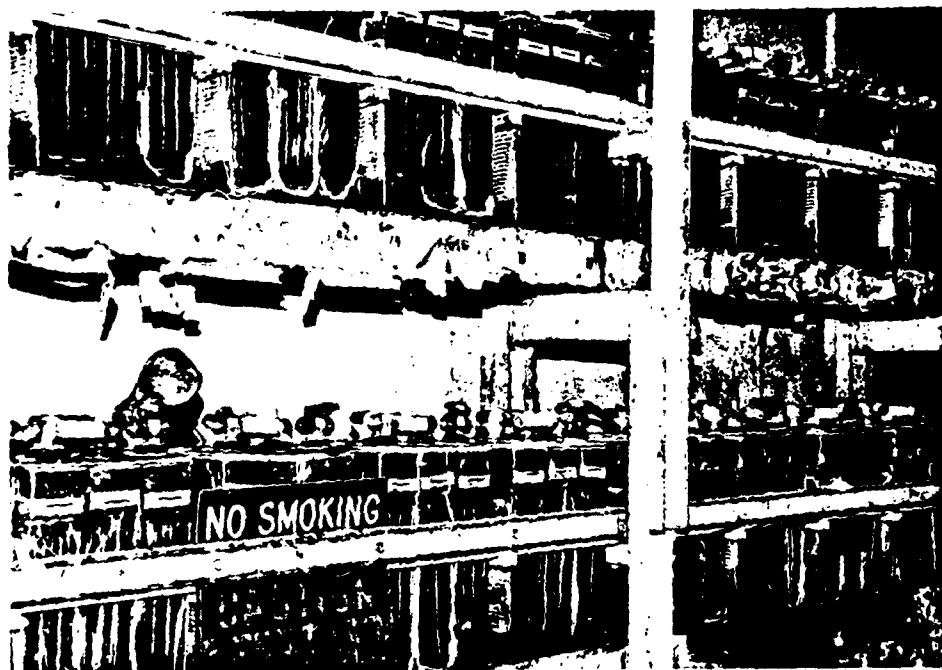
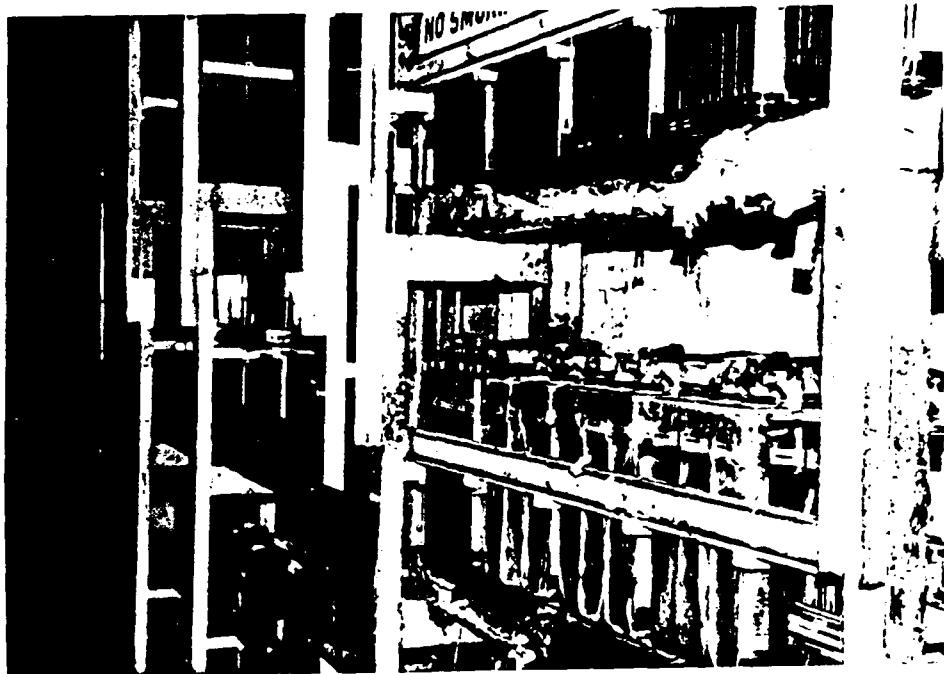
- The Equipment and Power Building contained fuel tanks, generators, damaged asphalt floor tiles, and 63 lead-acid batteries, 12 of which were intact. Photographs 36, 37, 38, 39, and 40 (Appendix E) show these items.

Photo 36. Equipment Bldg. - Fuel Tanks.

Photo 37. Equipment Bldg. - Generator.

Photo 38. Equipment Bldg. - Batteries.

Photo 39. Equipment Bldg. - Batteries.

Photo 40. Equipment Bldg. - Communications Equipment.

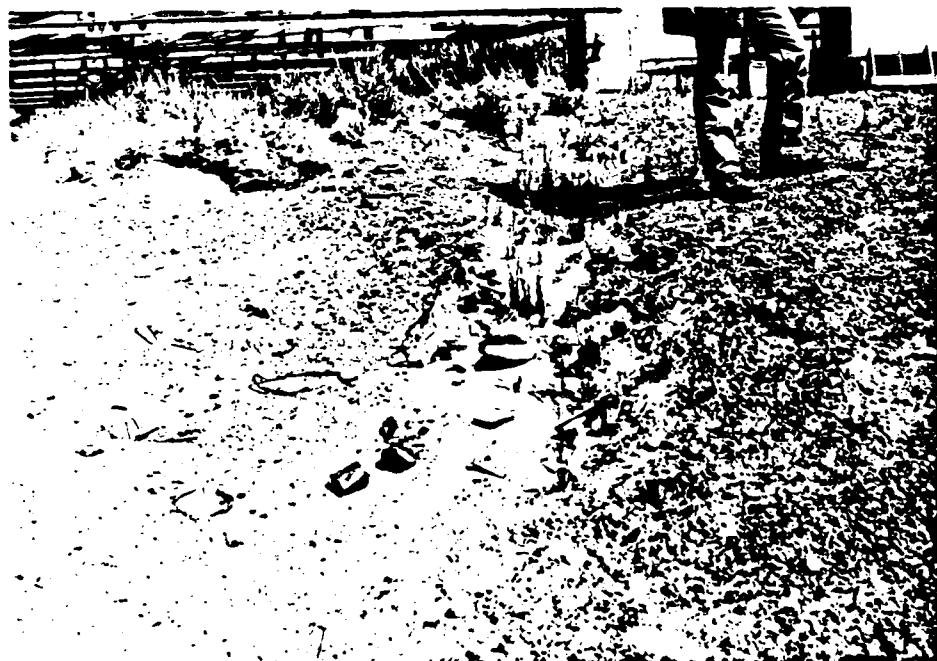
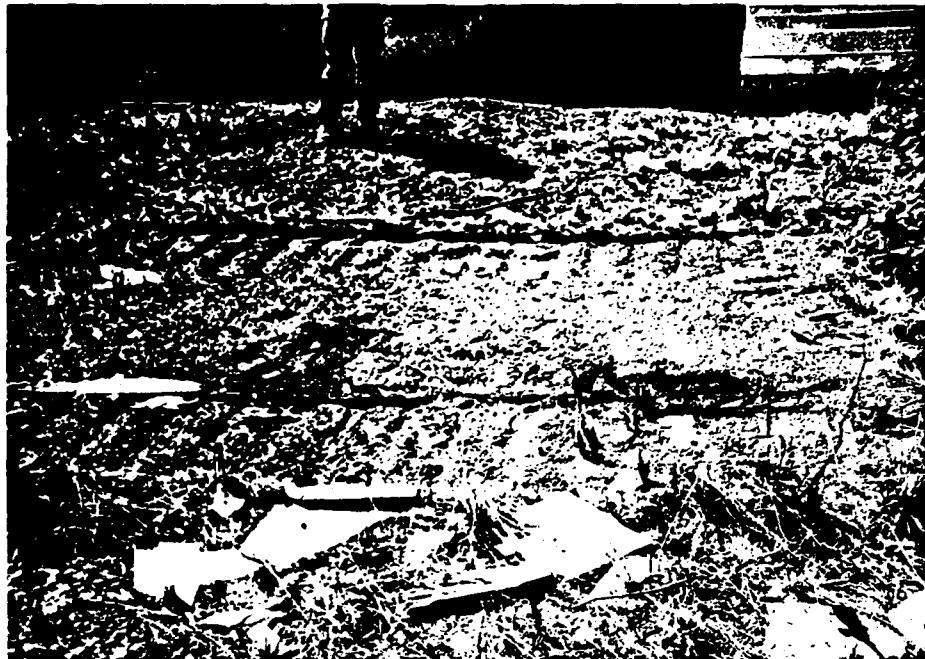
- In addition to the sites and buildings, additional 55-gallon drums, 5-gallon cans and general debris were found throughout the site (see Photographs 42 and 43; Appendix E) and in the adjacent foliage around the RRS. All of the containers were either empty or partially filled. Their condition varied from slightly rusted to crushed and/or gun shot. A PID survey was conducted on the drums to analyze for organic vapors. The results of this survey were negative.

Photo 42. General Debris - North of Antenna No. 2.

Photo 43. General Debris and Stained Soil - West of Support Facility Bldg.

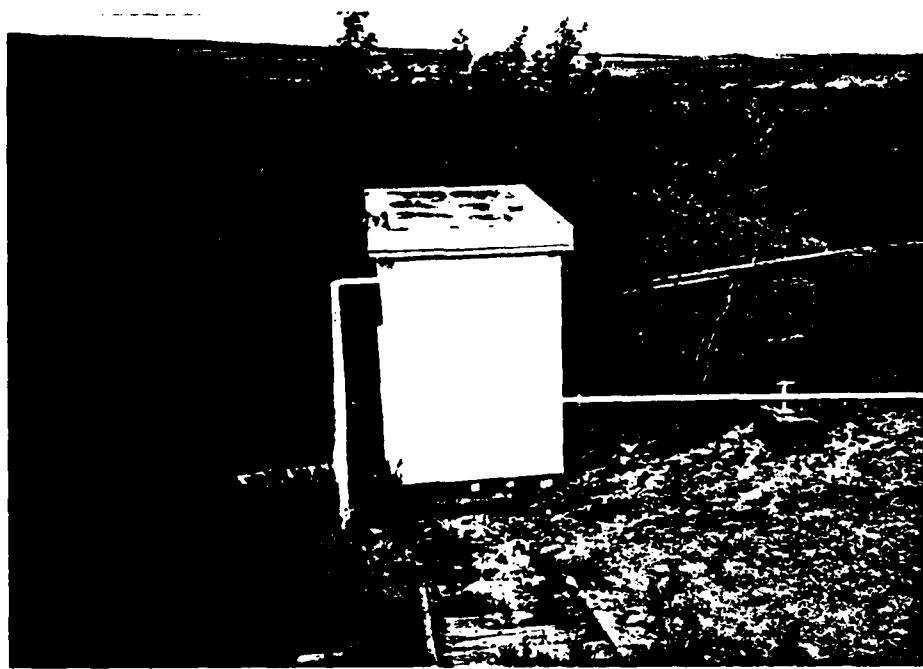
- A small building was located approximately 75 yards southeast from the main area (see Photograph 44; Appendix E). The building's interior was not accessible. Therefore, its function and contents could not be determined. General debris was found around the building including fire extinguisher canisters.

Photo 44. Unidentified Bldg. - East of Main Area.

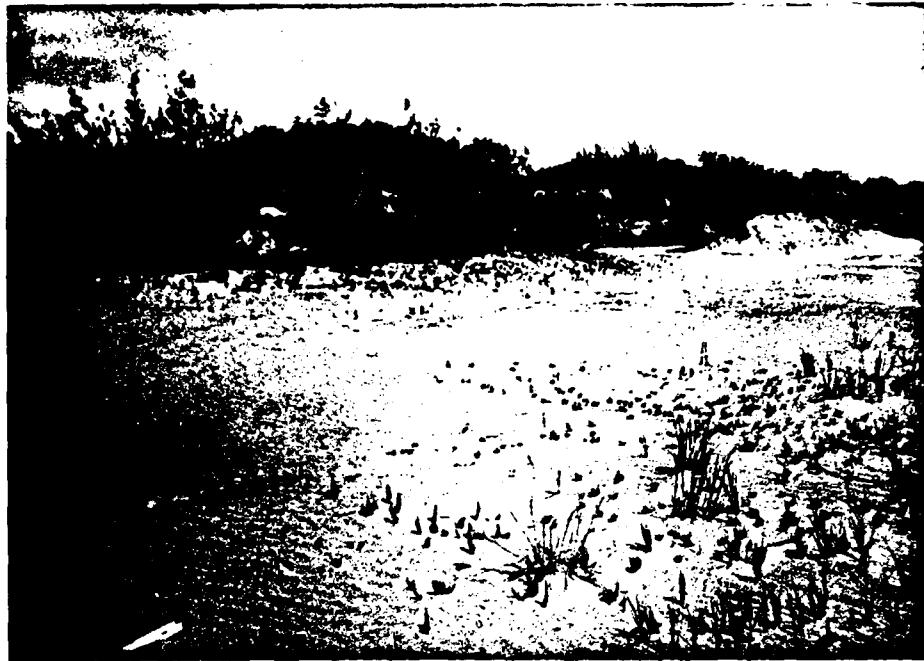
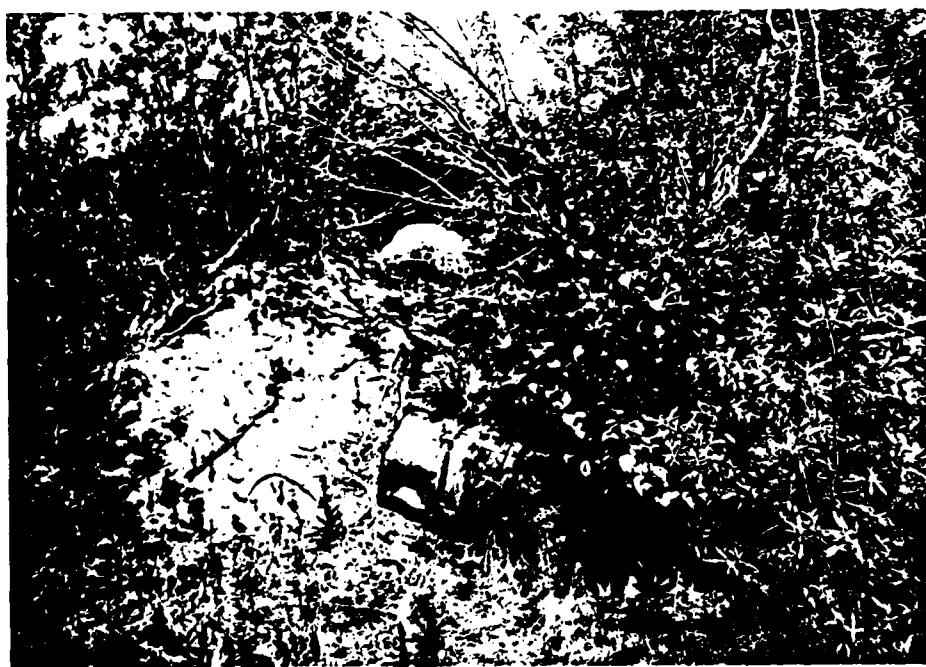
- Although a landfill on RRS property could not be located, it was common practice to bury drums and waste liquids at similar facilities.
- Approximately 200 yards on the east unpaved road, a landfill was located. The soil from the area had been removed, however, general debris including drums and cans were found. It is questionable whether this land is RRS property, since domestic debris was also found including furniture and children's bicycles. Photographs 45 and 46 (Appendix E) show this area.

Photo 45. Landfill Area - 200 Yds. East of Main Area (along East Unpaved Road)

Photo 46. Landfill Area - Close-up of Drum on North Edge of Area.
